**Summary of *Expedition 'Operation Dukedom'* which carried  
Explorers Club Flag #52 while surveying the wreck of  
*HIJMS Haguro*,  
Malacca Strait  
November 8<sup>th</sup> - November 23<sup>rd</sup>, 2010**

This report written and submitted by expedition member and E.C. Flag applicant  
Kevin Denlay, Fellow International 1998.

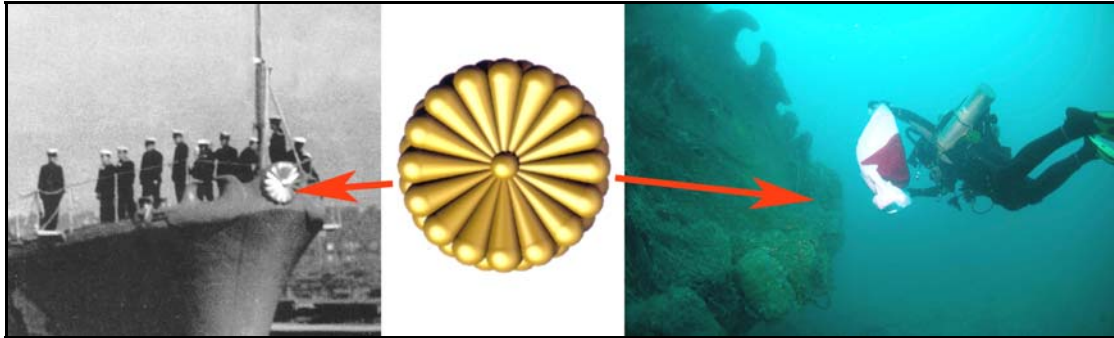
**THE DETAILS: BOW TO STERN:** *Haguro's* bow/foredeck is almost – but not quite - severed at about the leading edge of the #2 eight-inch turret. There is massive damage forward of this turret with both the port and starboard sides of the hull completely blown out, while a tangled mess of debris stretches for approximately 26mtrs/85ft – i.e. from the #2 turret to the anchor capstans - before what could be considered recognizable deck again comes into view. Just forward of the capstans there is small 'bite' out of the port side deck edge and upper hull, with the port anchor chain spanning this gap before exiting the hawse pipe. What deck remains intact forward of the capstans is tilted well over to starboard, so much so that the starboard deck edge now rests on the sea bottom until almost the very bow stem, which itself is fractured (broken) in half just above where the waterline would have been. The very tip of her bow at deck level, on which the Imperial Chrysanthemum emblem once so

proudly graced, sits about 2m/6ft up off the seabed tilted over at an angle of about fifty five or sixty degrees.

*All Japanese heavy cruisers had a large gold painted chrysanthemum (centre) on the bow, as seen in the picture at left. The diver at right is about to place a Japanese flag on the spot where the chrysanthemum once graced Haguro's bow.*

As stated above, the hull to both the port and starboard side of what was the #1 eight-inch turrets' position is spectacularly blown out as if this massive warships hull had been nothing but a thin soft-drink can. This is particularly obvious on the port side where the hull plates are actually peeled back aft-wards like a banana skin, and the port deck adjacent to the forward edge of #2 eight-inch turret is rent upwards in twisted disorder. [The manner that the hull plates are peeled back aftwards along the port side hull would imply that *Haguro* had substantial speed on when this damage occurred, which would correspond with historical reports of the timing of the first torpedo hit – or hits - in this area.] The destruction around #1 turret is so great that the turret itself has been completely uprooted with its barbette still attached – and now lies horizontally across the wreck - with the net entangled twin barrels of the turret pointing vertically towards the oceans surface; and the rear or back of the turret resting on the starboard seabed. The (starboard hull) damage in this area would also correspond with the reported position of one of the last two torpedoes to hit *Haguro*, which hit opposite, or just forward of, the #1 eight-inch turret. The roof of this turret has dislodged over time and has slewed down to now rest on the seabed behind the turret, allowing the breach blocks of the two big eight-inch guns to be clearly seen. [*If this turret were hypothetically stood back up into place the guns would be pointing out to port at approximately 9 o'clock, and the 'elevation' of the barrels would be relatively level. Note: For all gun angle descriptions in this report we shall consider the bow as the 12 o'clock position and the stern as the 6 o'clock position.*] As previously stated, it would not be an understatement to say that the ship is basically severed at the forward edge of #2 eight-inch turret, although it would seem that some of the ships bottom/underside must remain 'attached' for the ship to have settled to the seabed with the bow section to be still so well aligned with the rest of the wreck.

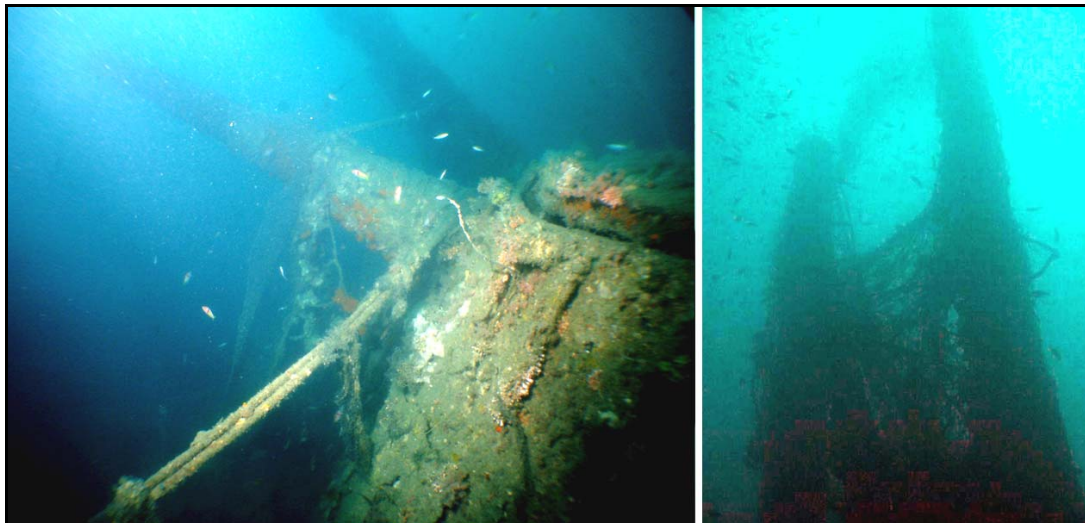
this is definitively now shown not to be the case. It would appear that the remains of the damaged guns were removed and the turret roof just hastily replaced.] The turret roof has deteriorated and collapsed to such an extent that a clear view into the turret from above is possible - and there are no barrels or breach remains to be seen anywhere. Of the four main gun turrets that remain upright - i.e. #2, #3, #4, #5 - this is the only turret with an inwardly collapsed roof, reinforcing the fact that the turret was only superficially - or cosmetically - refurbished while docked in Singapore undergoing her post Leyte repairs; and Japanese archive records from Singapore also confirm that repairs to *Haguro's* turret 'failed'. [*I believe the gun-less face of #2 eight-inch turret points to approximately 1 o'clock, but another expedition member thinks it points directly forward.* The 1 o'clock direction I believe this turret faces, if correct, agrees with the fact that when *Haguro's* #2 turret was knocked out by the bomb - during the Battle of Leyte Gulf - it was trained to fire off the starboard bow in pursuit of Task Force 3's ('Taffy' 3's) escort carriers. This would then imply that the turret was never even re-aligned, much less repaired, and the guns simply removed.]

**Right.** The barrels of the #1 8" turret, draped in discarded netting and now pointing vertically towards the ocean surface. **Left.** The askew barrels of #3 8" turret. Note how the roof and sidewall of the turret is just starting to delaminate, center right.

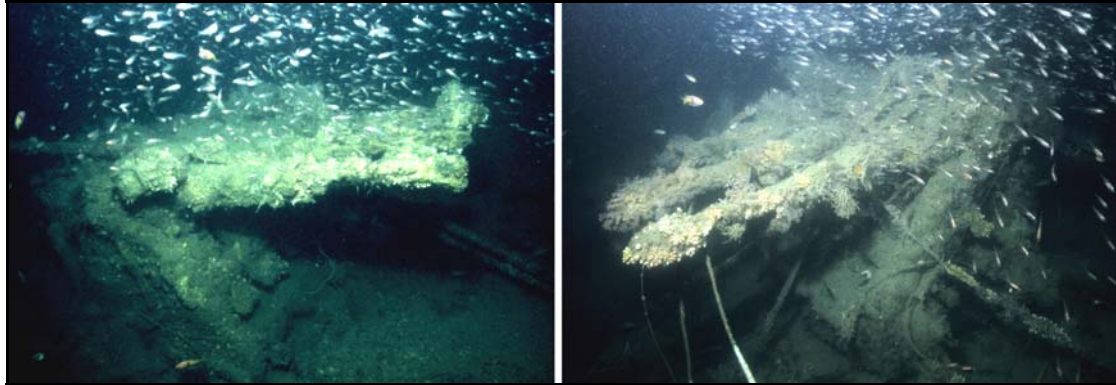
Just aft of the #3 eight-inch turret, and just forward of the bridge tower superstructure, are two triple barreled 25mm anti-aircraft (AA) weapons, situated on both the port and starboard deck. However, of note is there are no single barreled 25mm weapons, as shown on late war plans of *Haguro*, anywhere on the Foredeck. As a matter of fact, there has not been one single-barreled 25mm AA weapon found/seen *anywhere* on the wreck during any of the expeditions conducted to *Haguro*, or on other dives on the wreck since her 2003 discovery!

*The starboard and port triple 25mm AA guns on the deck forward of the bridge. Both these photos were taken in 2005, on a day when it was as dark as night on the bottom!*

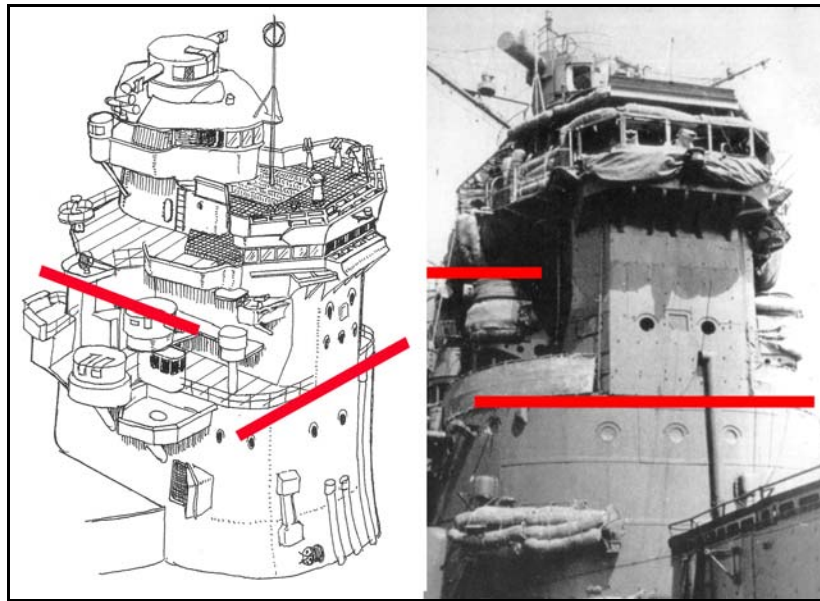
Just aft of the triple 25mm AA weapons is the bridge superstructure. The lower portion of what remains of this superstructure (i.e. three deck levels) is relatively intact up to what was once the floor of the Middle Bridge deck level, while the upper portion above that level (forward) is 'missing' – having collapsed. However, noticeable deterioration has occurred in this lower portion since I last visited the wreck in 2005, with the forward center of this structure collapsing outwards onto the Foredeck; in turn, surprisingly, spilling out some of the rectangular windows that were (originally) installed on the upper bridge levels (and that were not visible there at the base of the superstructure on previous visits). Finding those rectangular window frames there (i.e. 'spilled out' at the base of the superstructure) highlights the fact that the upper bridge levels have simply collapsed directly downwards over the years, as opposed to having collapsed off onto the port (or starboard) seabed as was once thought. What remains of the bridge 'tower' itself above the Middle Bridge deck level is higher towards the rear of the remaining structure than at the front - by about 5m/16ft or so - and is very heavily covered in numerous layers of netting and line (thick rope) that 'spider-webs' out onto the Foredeck and #3 eight-inch turret, down the rear of the superstructure itself across where the fore funnel once stood, and also out to either side onto both the port and starboard twin barreled five-inch high angle (HA) guns abaft the bridge itself. [The top of this net covered 'hump' at the rear of the remaining superstructure is now the highest, or shallowest, point on the wreck - at a depth of approximately 47m/154ft - while the depth on the deck adjacent to the superstructure itself is approximately 60m/197ft.] The deck on both sides of the superstructure is heavily covered with debris of all sorts from the upper bridge levels - especially so to port where it has piled up extensively - and the main (6m/20ft) rangefinder 'arm', once at the very highest point above the bridge superstructure, can now be found bent awkwardly amongst the pile to port. Various other items and apparatus from the upper bridge level's can also be seen amongst the piles of debris on the deck on both sides adjacent to the superstructure. Again, this simply confirms the fact that the upper bridge levels have collapsed directly downward over the years.

*The red lines on the above side view schematic (left) and forward view photo (right) of the bridge superstructure mark the highest levels fore and aft of the superstructure as seen on the wreck circa 2010. Everything above these levels has collapsed directly downwards.*

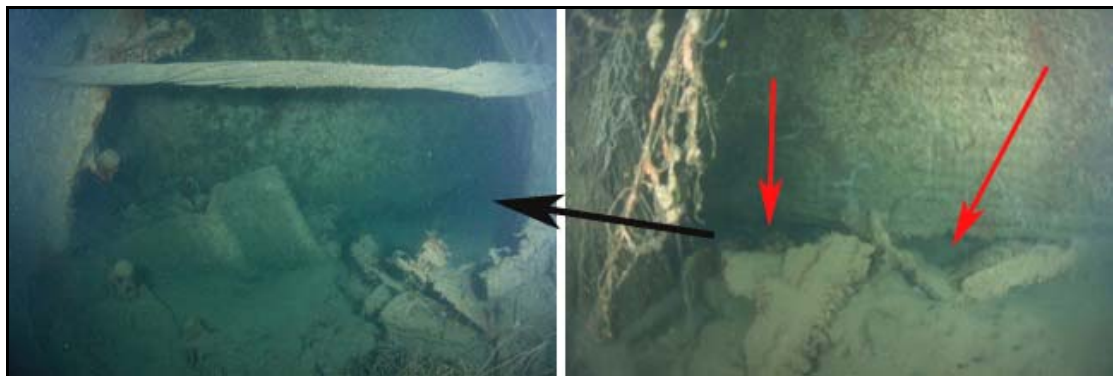
On the port hull almost directly below the aft 'side' of the forward port five-inch HA mount is evidence of a torpedo hit. However, the settling of the wreck into the seabed has obscured most of the actual hole; what is visible is the blown open outer torpedo bulge or blister, and a small space between the seabed and the bottom of the armour belt can clearly be seen, signifying that the destruction goes further *into* the ships innards. The 'top' of the damage to the torpedo bulge is 3m/10ft below the Upper Deck level, while the width of damage at the seabed is approximately 12m/39ft wide.

*The red arrows on image at right point to the gap between the seabed and the bottom of the armour belt, and is basically a 'close up' from just abaft where the black arrow points to in the picture at left - which itself is an image of the forward 'half' of the exposed damage. The horizontal 'line' across the upper left photo is netting.*

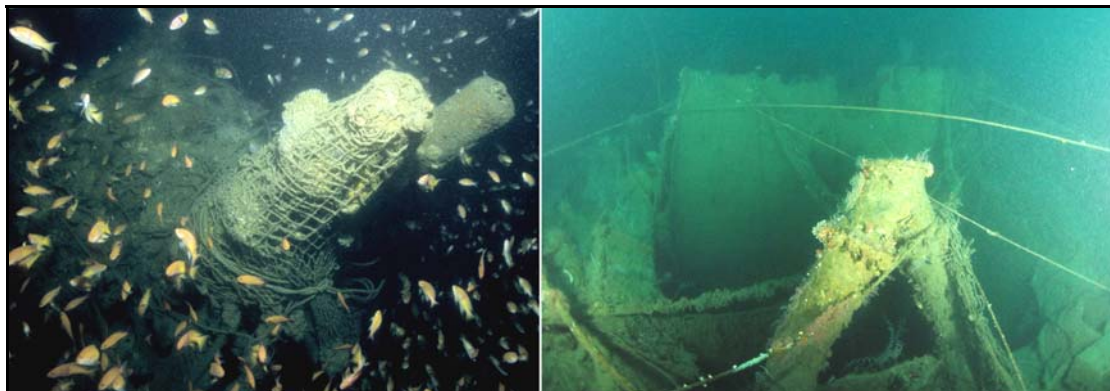
Where the aft funnel once stood is just a gaping hole (*above right*), while abaft it are the remains of the base of the collapsed tripod mainmast. Discarded netting stretches out from there and partially covers the port aft five-inch high angle (HA) gun mount, encasing one barrel (*above left*) of the twin guns which are raised almost vertical; *the mount itself now points forward to approximately 12.30 o'clock*. On the starboard side, outboard of where the aft funnel once stood is the remains of a 25mm AA gun director 'tower', now the highest point on the wreck amidships. Just abaft the director and inboard from the starboard aft five-inch HA gun mount is a twin 25mm AA gun collapsed down onto the deck. These 25mm guns can be seen in the image below (*bottom left*); the top photo is circa 1942, the lower photo as seen on the wreck today.

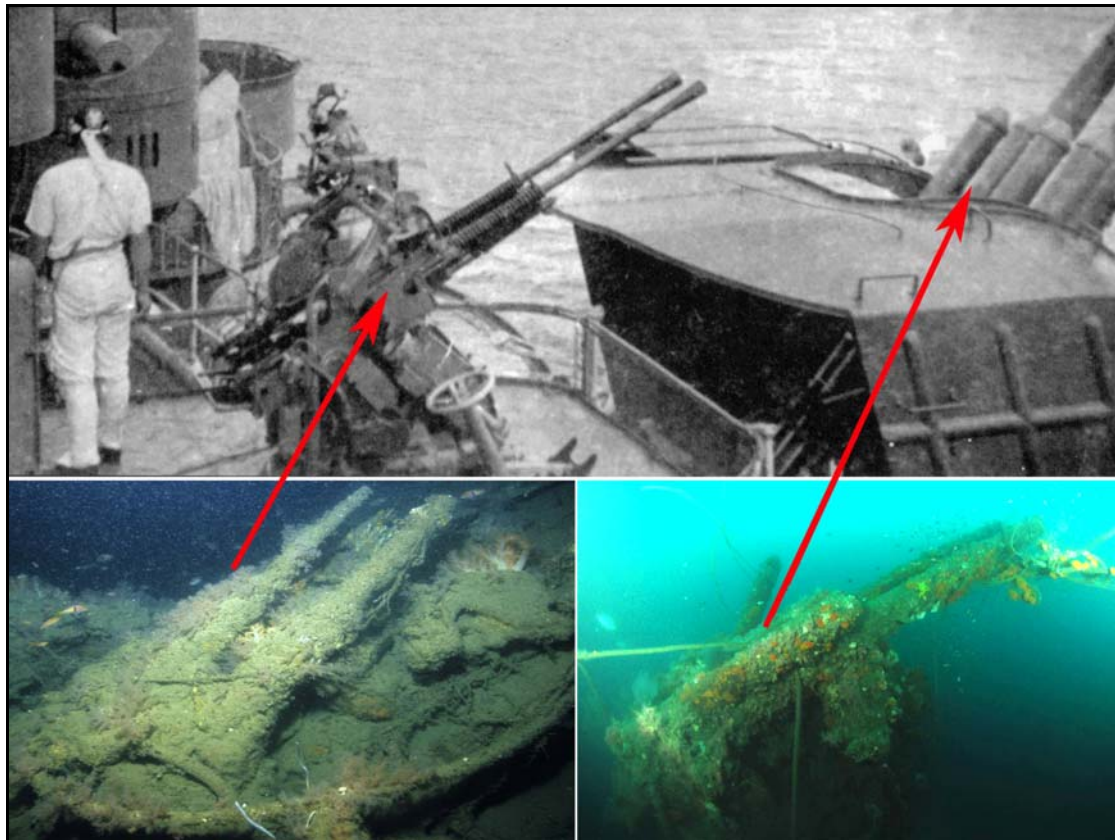
The starboard aft five-inch HA gun mount (*guns above bottom right*) is also draped in netting - which stretches down from there onto the seabed - while its twin guns are elevated to about thirty degrees; *the mount itself points to approximately 3.00 o'clock*. [Note: the actual gun-crews protective enclosures on *all* four of the five-inch HA gun mounts have completely rotted away leaving the barrels/breaches totally exposed.] The main tripod mast itself has completely collapsed to starboard and one of the 'legs' (*below left and right*) is laying across the deck and out over the deck edge just abaft the starboard aft five-inch HA mount, where it is also draped in the ubiquitous netting.

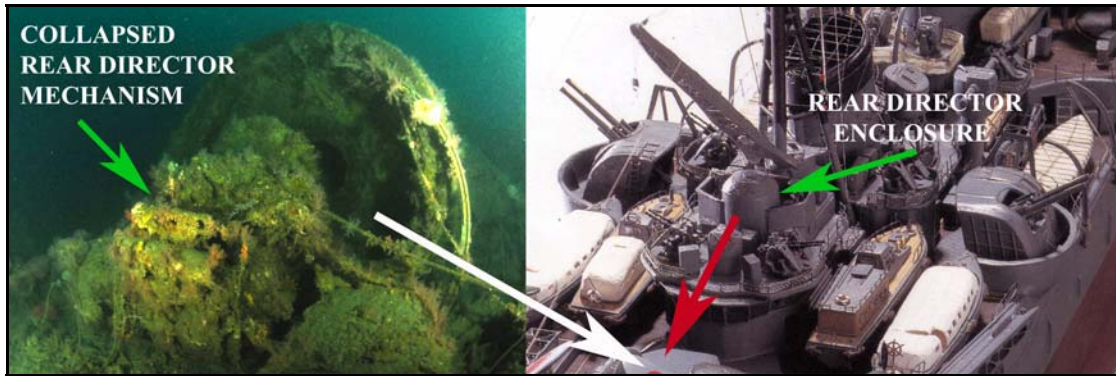
Abaft of the fallen mainmast is the now collapsed auxiliary main-gun director 'tower' - which has collapsed almost directly aftwards and is now laying aligned along the centerline of the ship - with its outer metal 'shell' rotted away and the director mechanism itself now spilled out onto the deck (*see top image page 27*).

**Right.** The green arrow points to the aft auxiliary Type 94 director enclosure (on a model) while the red arrow points in the direction which the whole structure has collapsed. *Note:* Although the model (and 1944 refit plans) shows twin 25mm AA guns abaft the director, the wreck shows that triples were fitted in their place. **Left.** The collapsed director as seen on the wreck. The white arrow points to where it now lies.

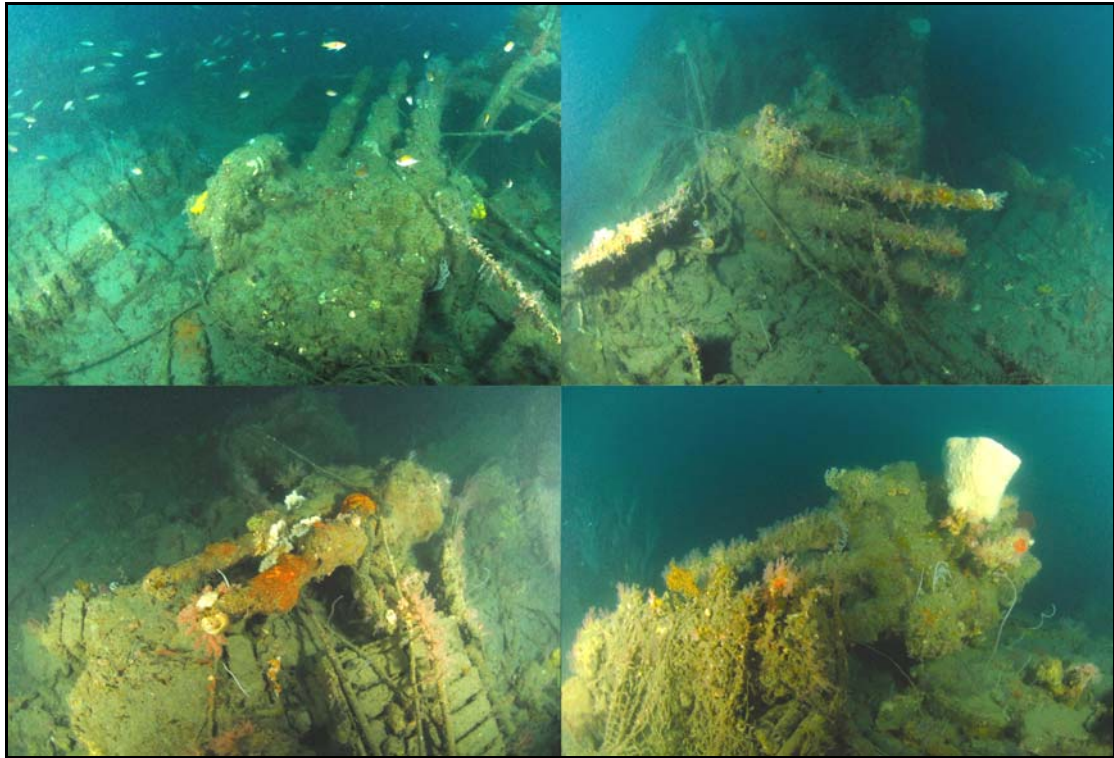
**Top left;** Triple #1 sits upright. (Note the numerous 25mm AA ammunition reload cases that can be seen in left of picture, while Triple #2 can just be seen top left corner.) **Top right;** Triple #2 is on its side, **Bottom left;** Triple #3 sits upright, upon a stack of 25mm AA ammunition reload magazines, with one barrel (far left) broken off. **Bottom Right;** Triple # 4 is on its side

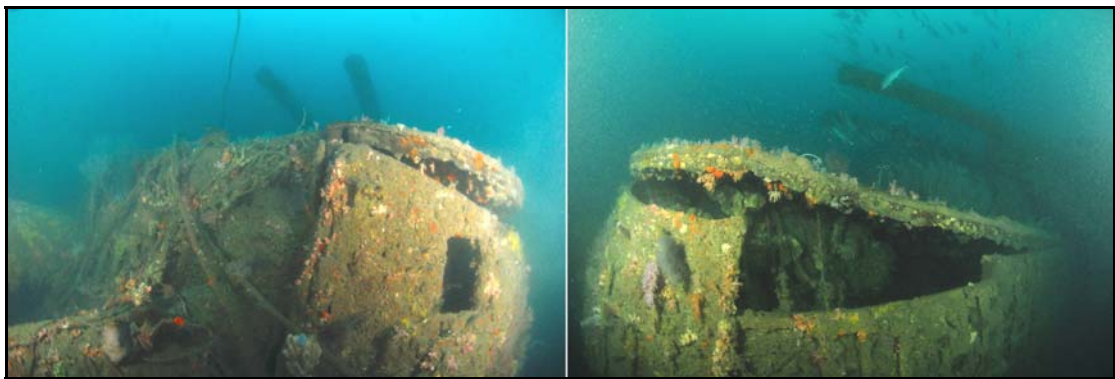
The #5 eight-inch turrets roof has also 'delaminated' at the edges from the sidewalls and face (*above left*) and part of the starboard sidewall is collapsing down towards the deck (*above right*); its askew barrels just visible lower left. [*The barrels of the guns in #5 eight-inch turret point directly astern, that is to the 6 o'clock position and are slightly askew; the port barrel basically level with the starboard barrel having actually collapsed down somewhat.*] Visible inside this turret are several 'sets' of undisturbed human remains, some still with gas/smoke masks 'in place' as it were.

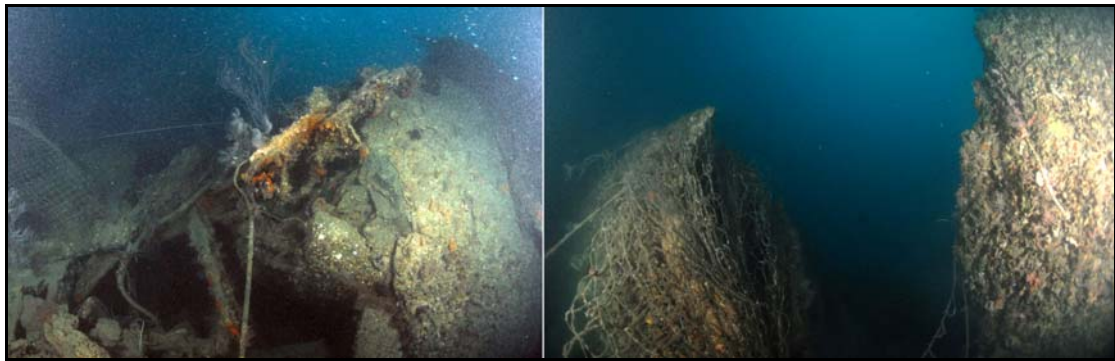
There is then a wide V shaped gap spanning about 6m/20ft until the Quarterdeck resumes, and the section of the ship aft of the break has now settled several meters lower than the deck abreast the #5 turret. That is, the deck on this very aft section, while relatively level 'longitudinally' along its centerline, has pulled away from and settled down deeper than the deck outboard of the rear (#5) eight-inch turret. However, when looked at from outboard of the wreck, this V shaped gap in the hull has relatively 'even' edges. That is, the break/gap does not look like it was caused by a direct torpedo hit to that location; more like the stern section has simply collapsed/pulled away at this point with the ships bottom acting as a 'hinge'. Once across the gap the starboard side of the Quarterdeck itself is basically intact *almost* all the way to the very stern, although the deck near the edge of the break has collapsed – just like the deck abaft the rear turret - into the gap. However, on the port side, after one crosses the gap, a very different scene unfolds than that on the starboard side; that is, the deck is to some extent a shambles. As a matter of fact, the whole port side deck on the stern abaft the break is a rather confused mess with little symmetry to it at all.

**Right.** Looking up at the break in the hull on the starboard side, aft edge to the left. Both port and starboard splits in the hull look similar, with little or almost none of the ships innards spilled out onto the seabed. [The use of an ultra wide 'fisheye' lens makes the break look much narrower than it actually is] **Left.** Looking up at the aft edge of the 'bite' out of the hull just aft of the 'V' shaped break on the port side. Here the innards of the ship have spilled out and down over the port outer propeller and propeller shaft itself. The stern hull-side is the 'lighter' shaded area at right.

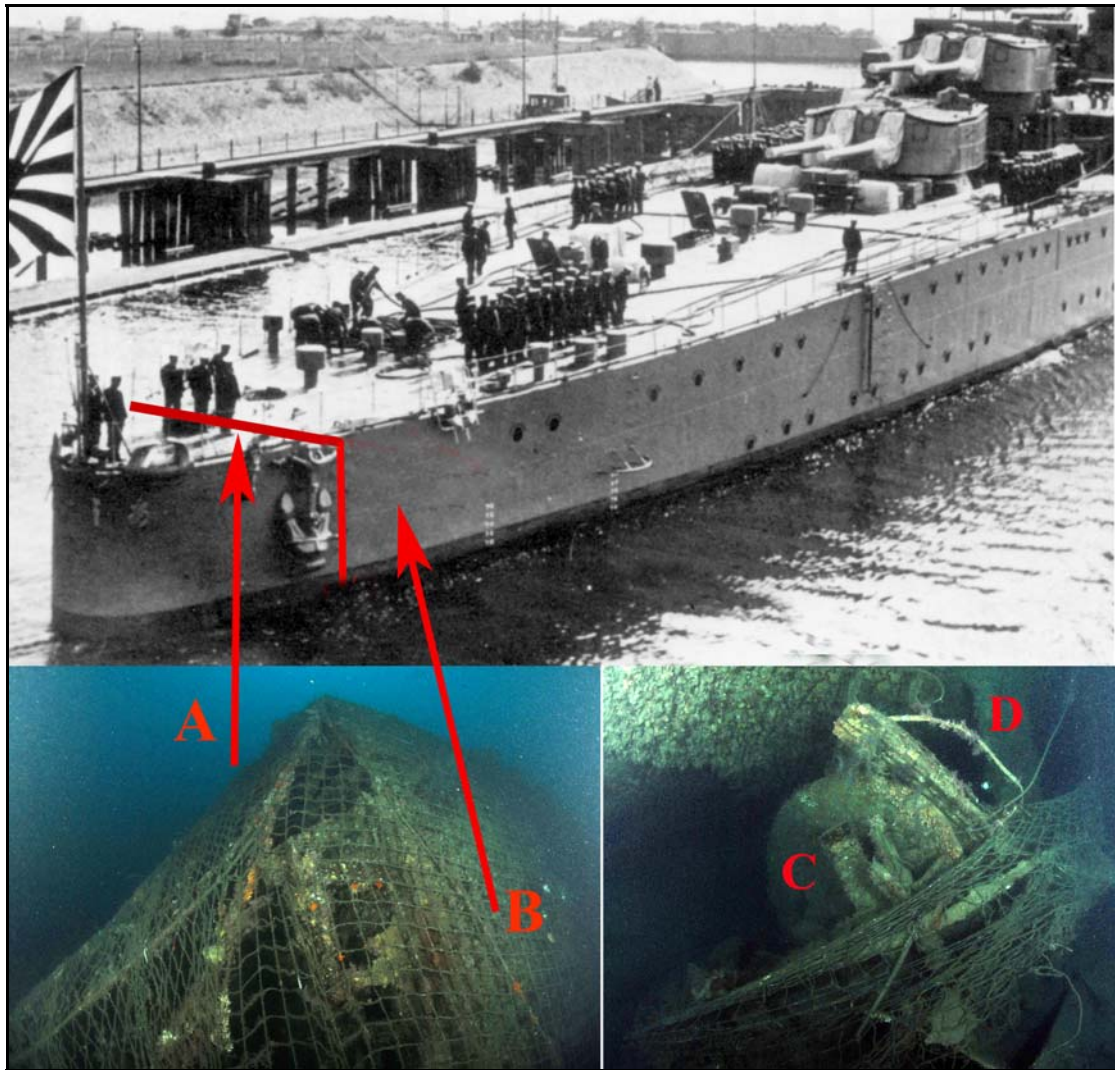
**Bottom left.** The squared-off stern deck edge is directly beneath A arrow, which points to the corresponding position, i.e. the red line across the deck in top photo. B is the starboard hull side. The whole area is incased in net. **Bottom right.** C is one of the blades of the starboard outer propeller (the other two blades are hidden behind the netting), D is one 'arm' of the A Bracket that holds the propeller shaft to the hull.

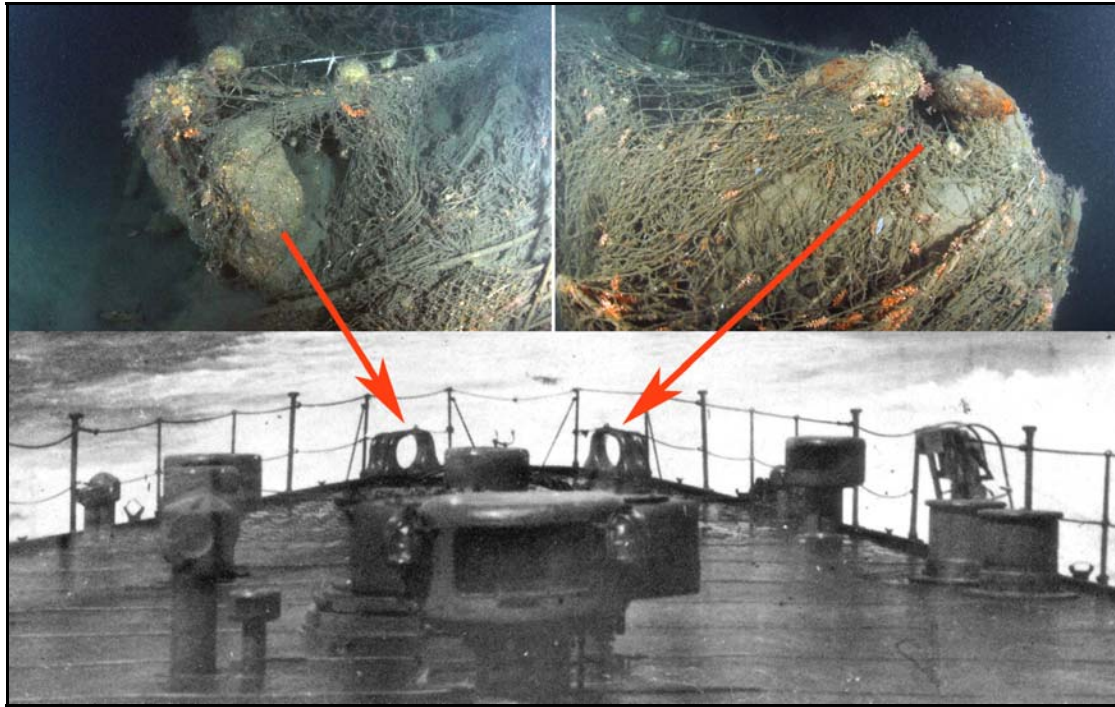
There is a substantial amount of trawler net and heavy line covering the sheared off stern area, all hanging down to the seabed over the now squared off Quarterdeck edge. Follow that net and line down to the seabed and some of the deck and upper hull edge *only* (i.e. almost *no* hull) of this very aft-most piece of stern (i.e. about the last 6m/20ft or so of the rounded off Quarterdeck itself) can be seen elevated about 1m/3ft or so just up off the seabed, with the two aft-most fairleads clearly visible although encased in netting (*see above image*). Because of the amount of netting and several hull plates hanging down onto the seabed at or under the stern, coupled with the collapse of the last 6m/20ft of the very stern itself, and its associated debris, the rudder could not be seen. It remains rather odd however that the aft-most part of the hull itself – i.e. from that 6m/20ft stern piece that has 'sheared off' and collapsed - is mysteriously 'missing' and it is only the very deck itself with the smallest amount of hull beneath, little more than the deck edge itself, that now sits on the seabed.

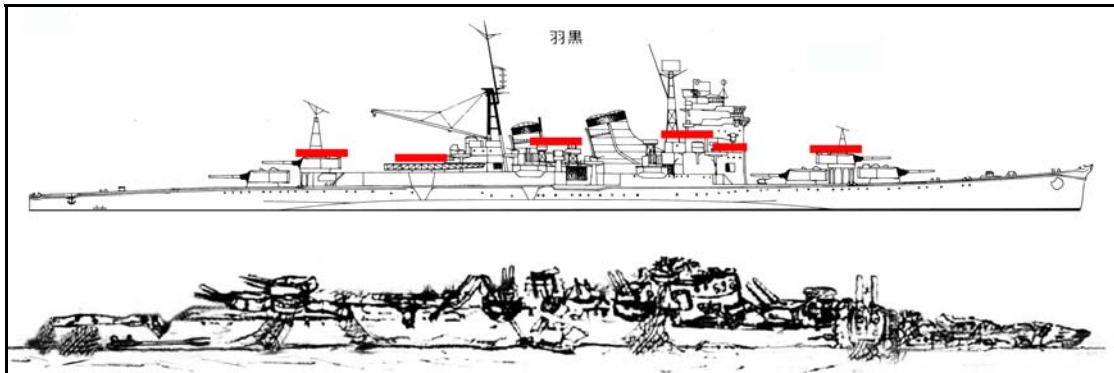
*The red lines on the upper schematic depict the highest points at various locations along the wreck, 2010. The lower image is an 'updated' version of a sketch historian and author Tony Tully made after discussions with this author circa 2004. That is, in 2010 we found that the seabed was not at the ship's waterline as originally envisaged, but much lower, and that the outer propeller shafts were visible above the seabed; so his original sketch was 'altered' to take that and other new information into account.*
